Inspection Report

Mountain View Home Inspections

12 Mountain View Road

South Paris, ME

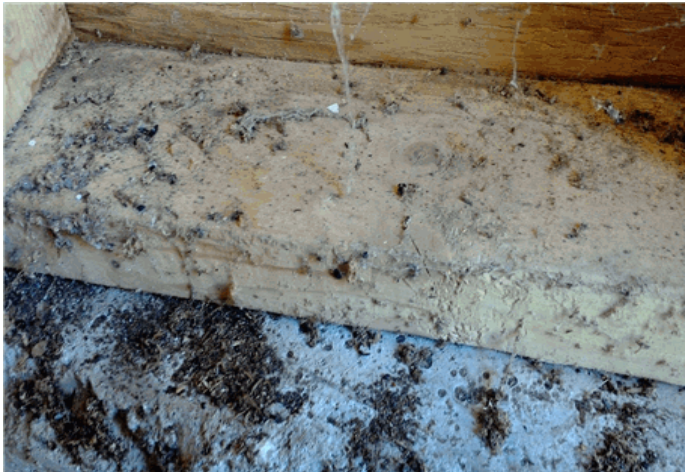
5) Back Entrance Conditions

Suspicion of ant activity.

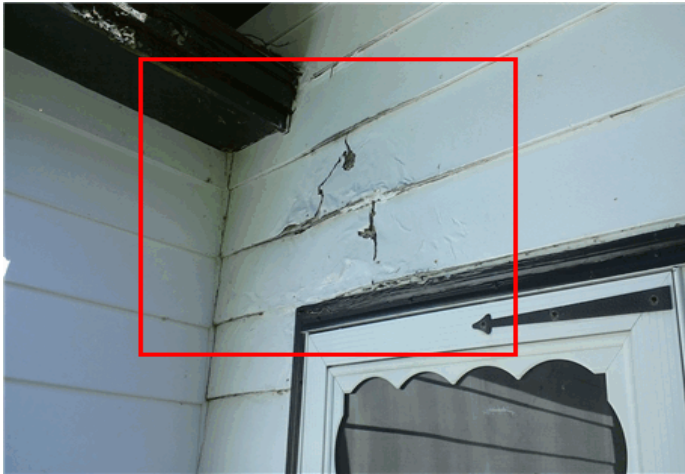
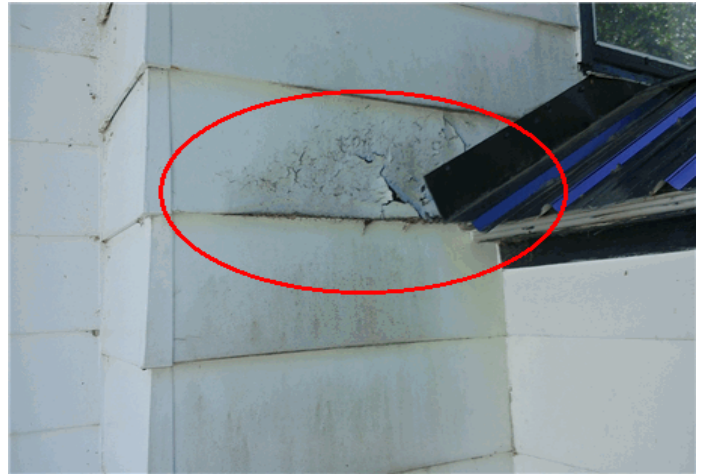
6) Exterior Wall Conditions

There are many places where water from the roof has damaged the siding. Gutters would be a great help to prevent further damage. Damaged areas should be replaced. Color lock masonite siding is notorious for water damage. I would suggest removing good siding from the rear of the garage to repair siding on the main house. Then put vinyl siding on the garage.

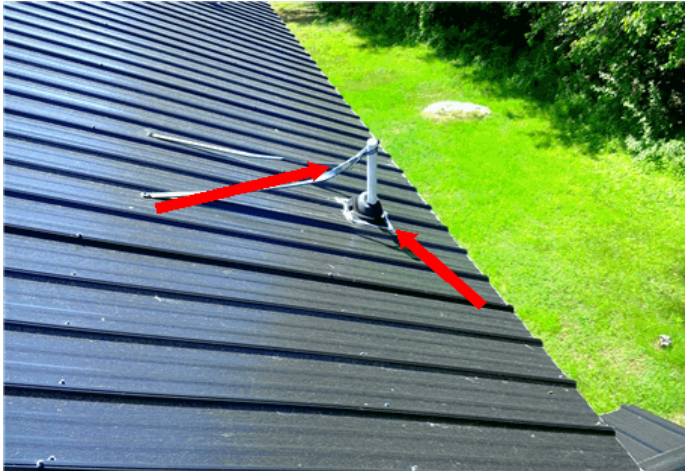
14) Flashing Conditions AS The vent pipe is leaning and the brace is broken on one side. From the attic this vent pipe could not be seen. Question whether it has been disconnected from the inside. Recommend having a professional plumber check this pipe. There is no evidence of water leaking in.

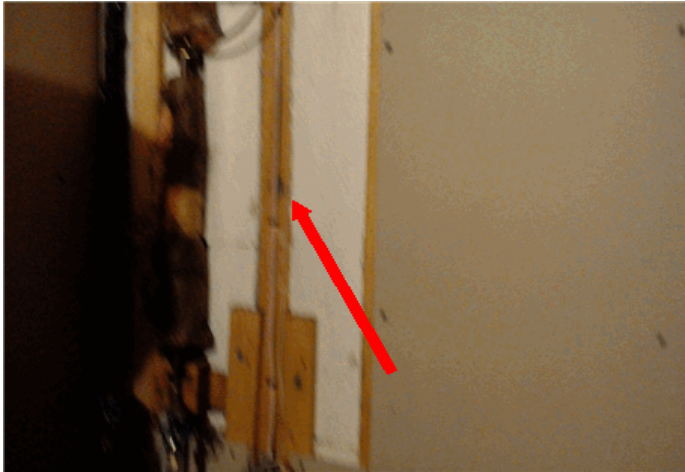
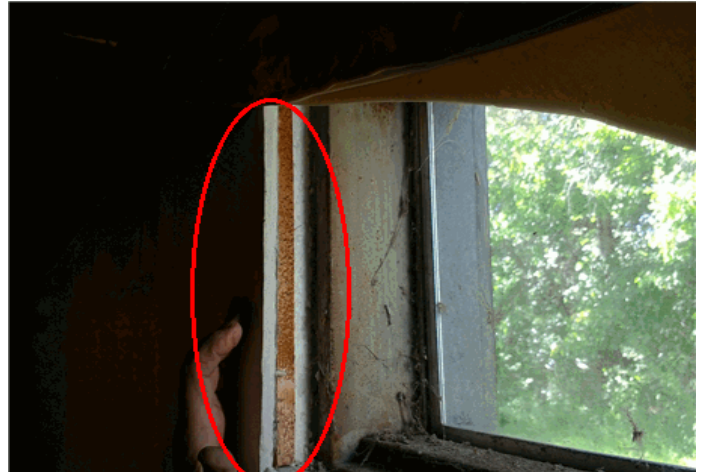
36) Wall Conditions

The walls were cover with sheetrock over styrofoam insulation and strapping.

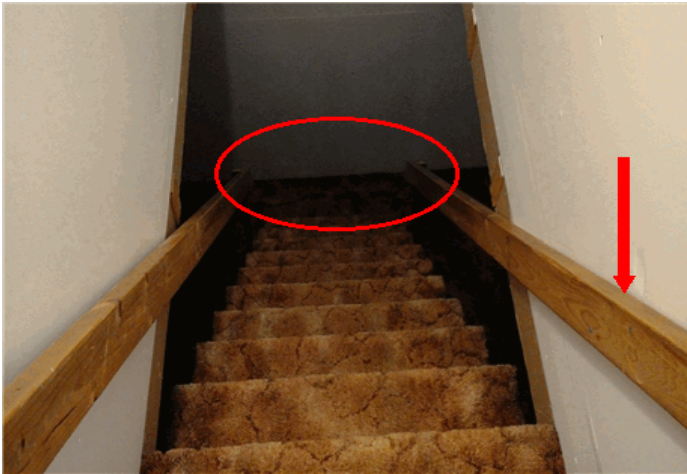
47) Stairway Condition **S** Basement stairs are steep, and the landing is very small.

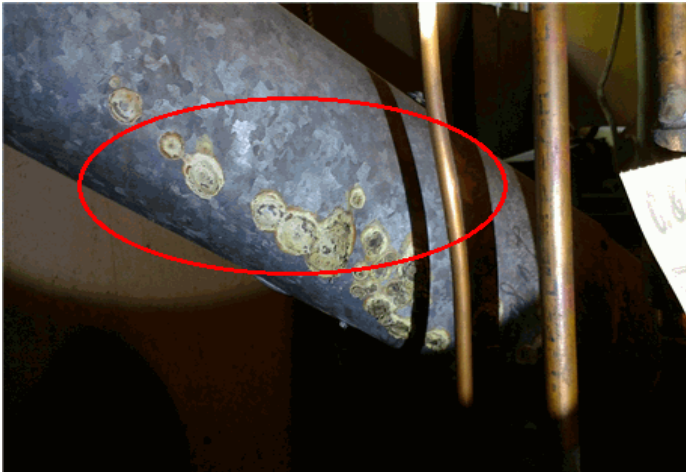
49) Unit Conditions AS Crown Montego xe. with Beckett burner. Not functional at time of inspection because the water is off. Dan Connell put 9 gallons of anti freeze in system. Last serviced 4/15/14. Mixer valve not working. Flue pipe is pitted and ash found at the damper. All systems should be up and functioning before closing.

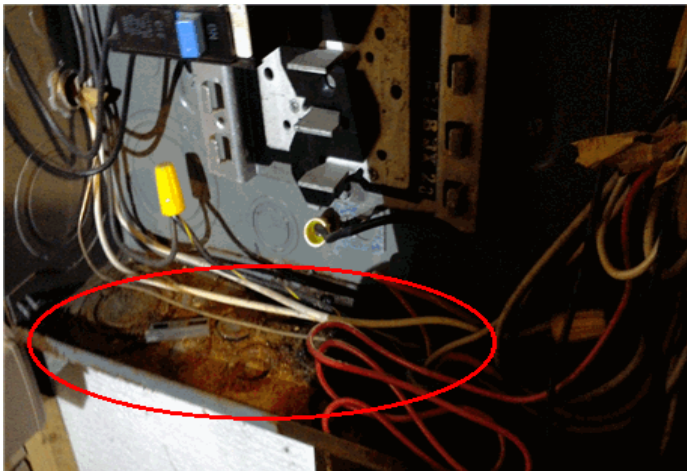
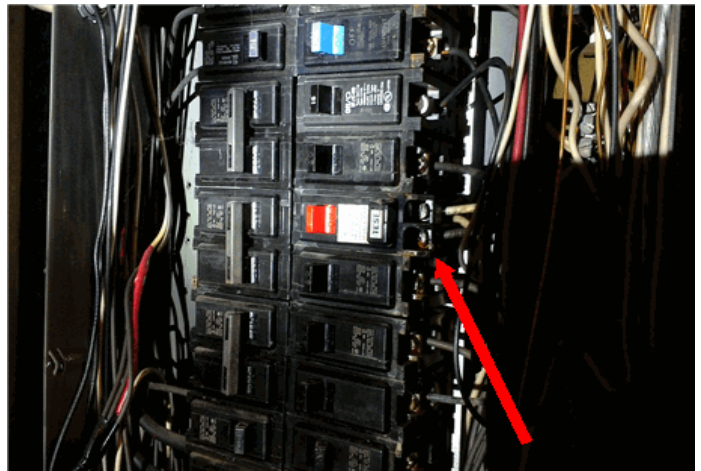
57) Electrical Panel Conditions

There is evidence of moisture in the panel. Some of the breakers need replacing because of rust.

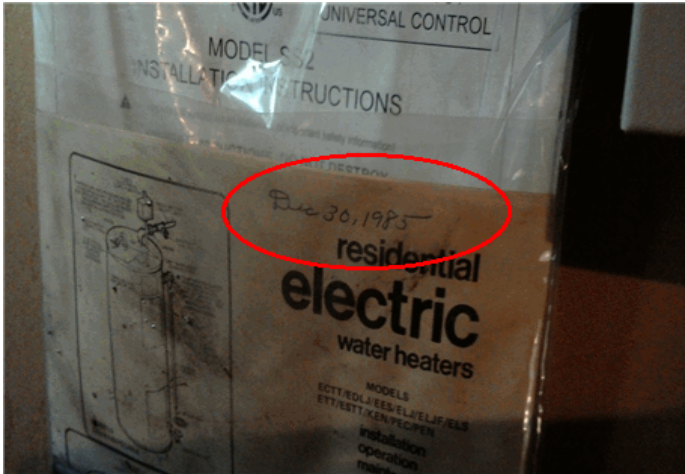
62) Water Heater Conditions

AO Smith in excess of 30 years old. Way in excess of an electric water heater.
