Mountain View Home Inspections

Property Inspection Report

, New Vineyard, ME 04956

Date of Inspection: 12/7/2020 Time: 9 am

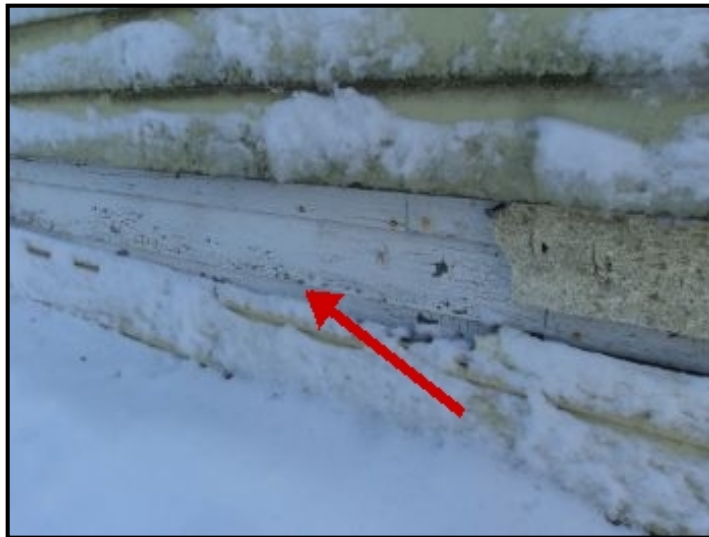
3. Siding Condition

Page 9 Item: 3	Siding Condition	<ul style="list-style-type: none"> Aluminum siding missing on the north side at the back of the house. Repair as needed.

- Aluminum siding missing on the north side at the back of the house. Repair as needed.

The aluminum siding has blown off of the house on the north back end of the house.

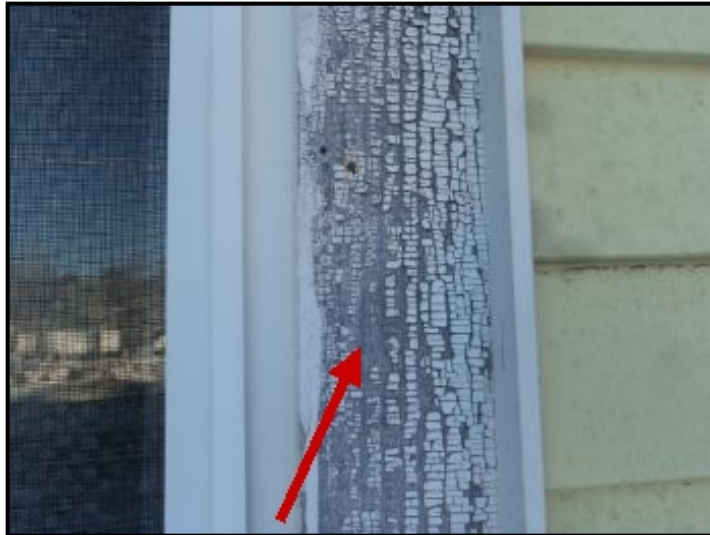
Page 10 Item: 5	Exterior Paint	<ul style="list-style-type: none"> Cracking paint observed around the doors, windows and trim. I suggest scraping and painting as necessary. Remember a house of this age has a chance of having lead paint. Precautions should be taken to dispose of all paint chips.

- Cracking paint observed around the doors, windows and trim. I suggest scraping and painting as necessary. Remember a house of this age has a chance of having lead paint. Precautions should be taken to dispose of all paint chips.

The trim around the doors, windows and fascia all need to be scraped and painted.

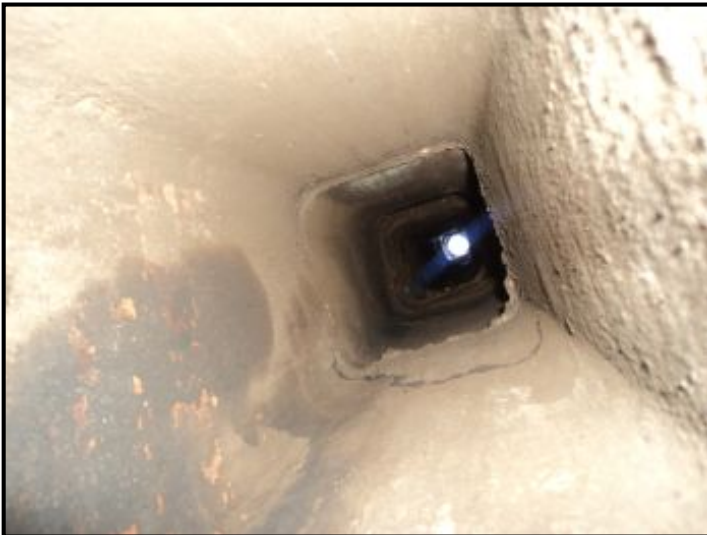
Pictured is the block chimney flue from the clean out that both wood stove and pellet stove us.

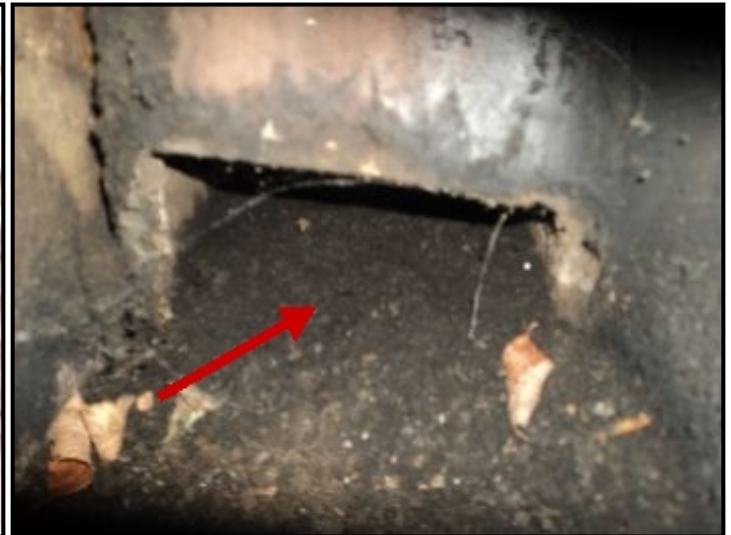
- No chimney cap noted on the back chimney. Recommend installation to prevent premature weathering, water intrusion, and nesting of wildlife. Contact licensed mason for further evaluation and repair.
- Chimney clean out in the kitchen for the wood stove flue needs to be cleaned.

The chimney needs to be cleaned from the clean out in the kitchen.

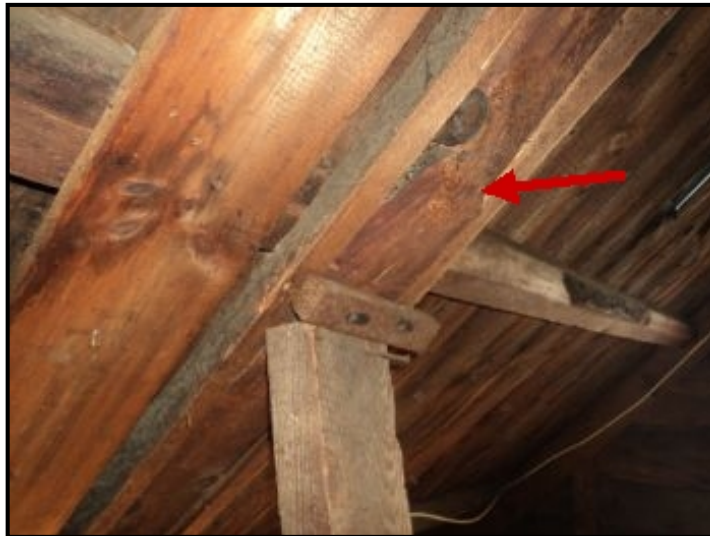
Page 13 Item: 2	Structure	<ul style="list-style-type: none"> NOTE: One beam was cracked and supported as noted in the picture.

- Post and beam structure noted.
- **NOTE: One beam was cracked and supported as noted in the picture.**

There is one cracked rafter in the attic over the back storage area.

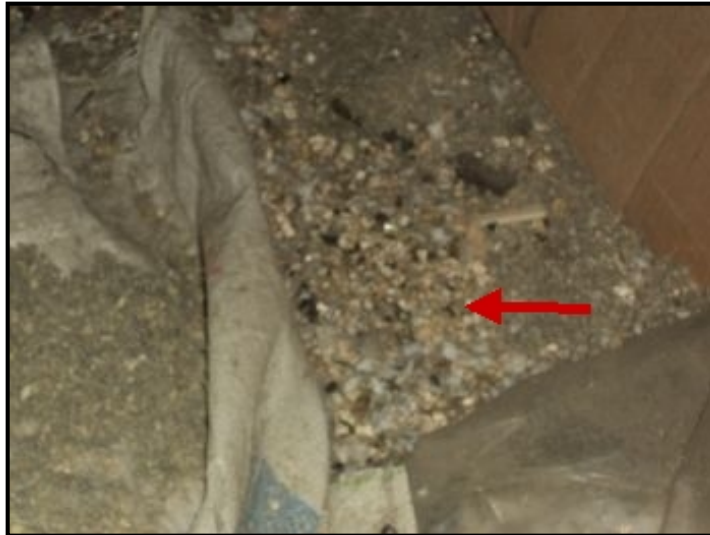
4. Insulation Condition

Materials: Blown in **cellulose** insulation noted. • Vermiculite noted. Do not disturb this insulation. This insulation could contain asbestos. Caution should be taken if the insulation is moved at all. Wear a respirator.

The attic insulation over the kitchen area is mostly cellulose, but there is some vermiculite noted.

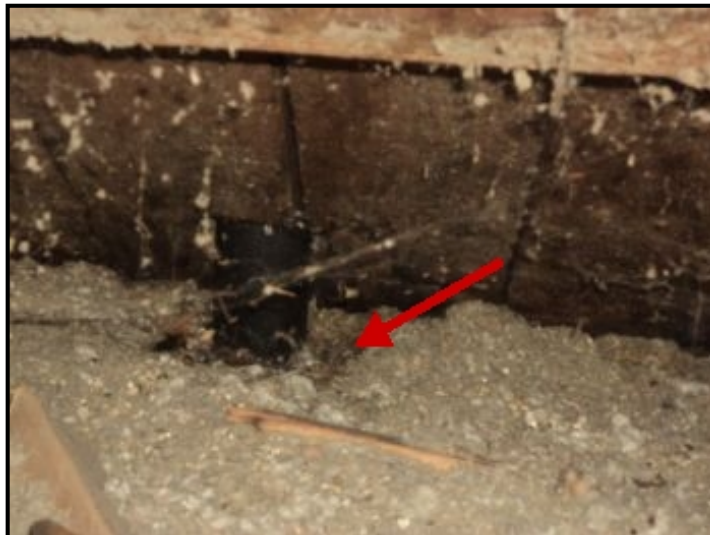
5. Attic Plumbing

Page 14 Item: 5	Attic Plumbing	<ul style="list-style-type: none"> The plumbing vent pipe appears to be leaking around the ring on the roof. I recommend sealing around the cast iron pipe or replacing the waste vent pipe with a PVC pipe and new boot to seal this area properly. Contact a licensed plumber for repair.

- The plumbing vent pipe appears to be leaking around the ring on the roof. I recommend sealing around the cast iron pipe or replacing the waste vent pipe with a **PVC** pipe and new boot to seal this area properly. Contact a licensed plumber for repair.

Pictured is the plumbing vent pipe and the wetness around the pipe in the attic.

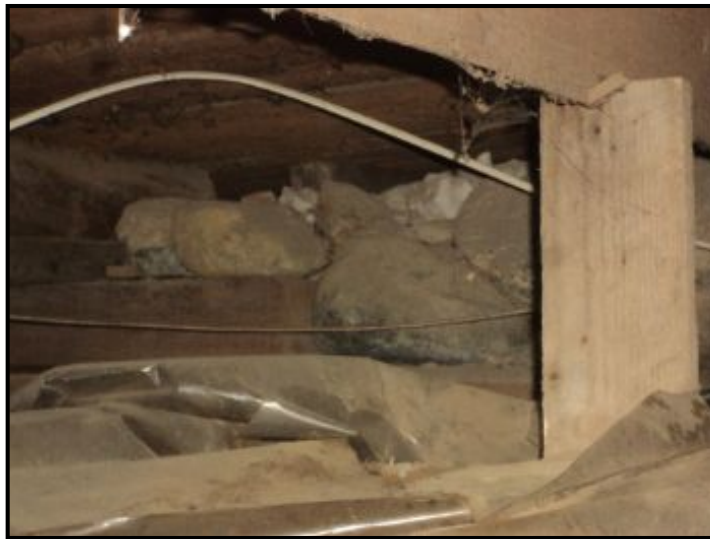
In the center of the crawlspace there is an old chimney that is no longer used. That is the pile of stones seen in the picture.

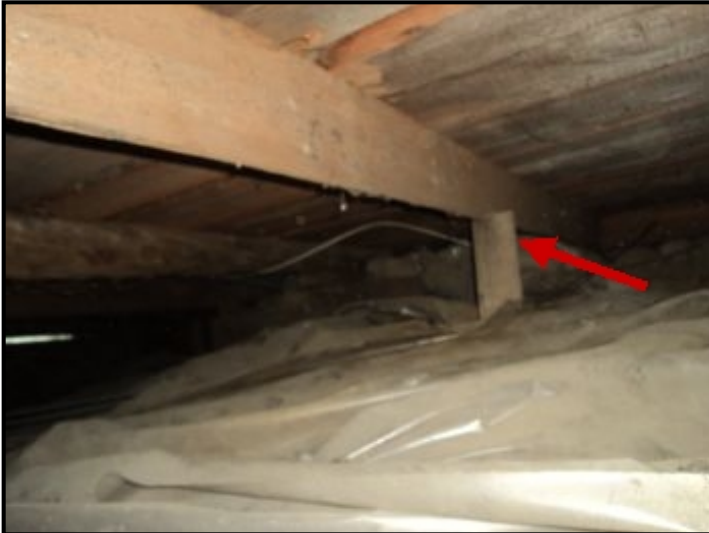
The crawlspace area of the house is supported by granite slabs. This 2x6 floor joist has a 2x4 support.

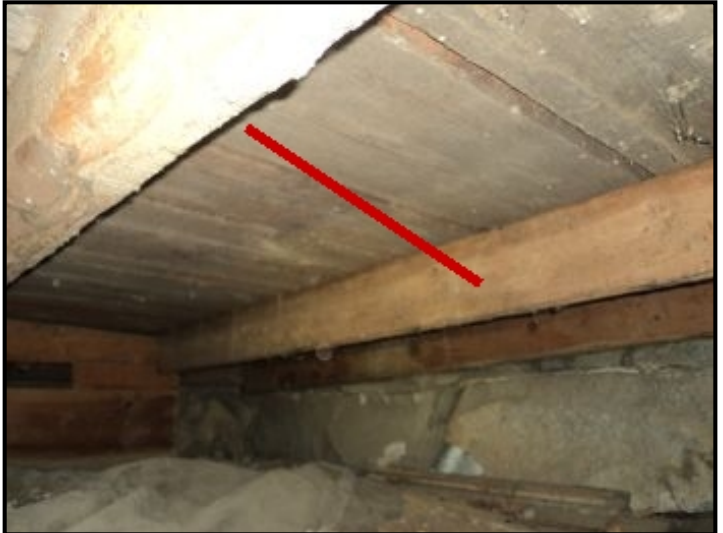
The wood purlin floor supports are spaced almost 36 inches apart.

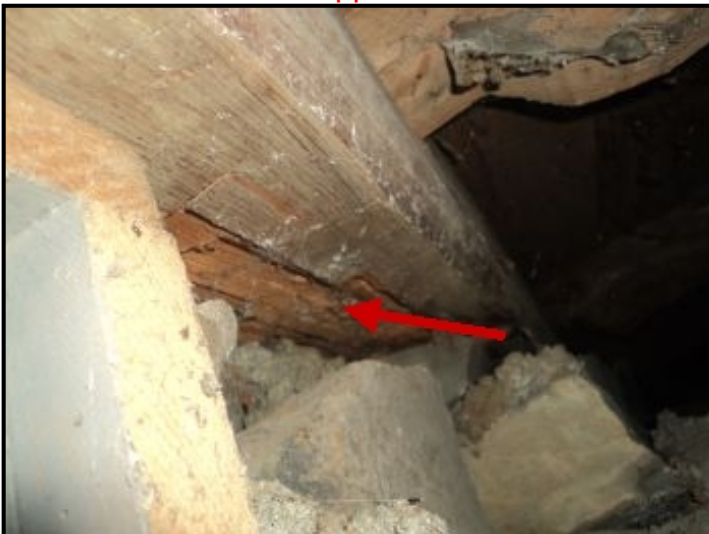
There was a little dry rot noted on the north sill. I was unable to crawl under the crawlspace because of the low head room and the electrical ground rod.

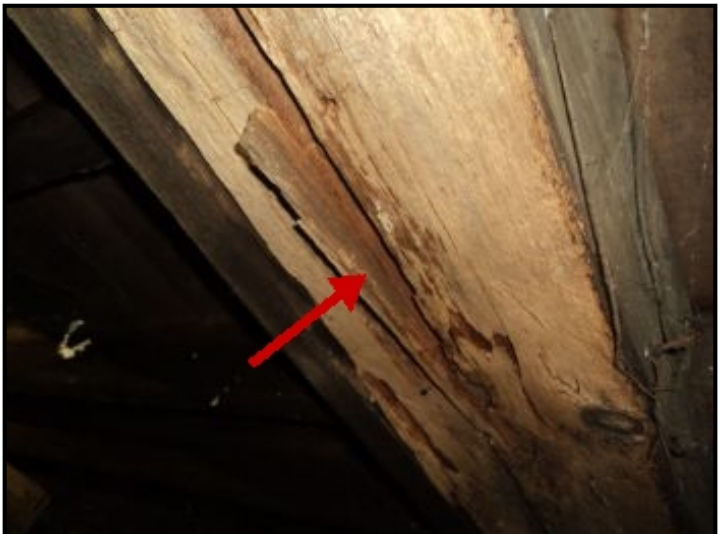
Pictured is the main beam in the basement that could be viewed from the basement stairs. It has dry rot noted. I could not reach this beam to see the depth of the rot.

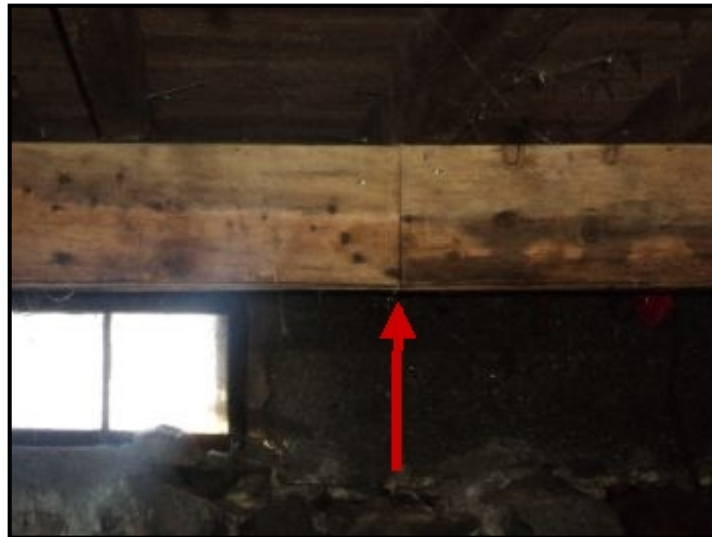
Another beam in the basement had been replaced, but was missing a support post on the break in the beam.

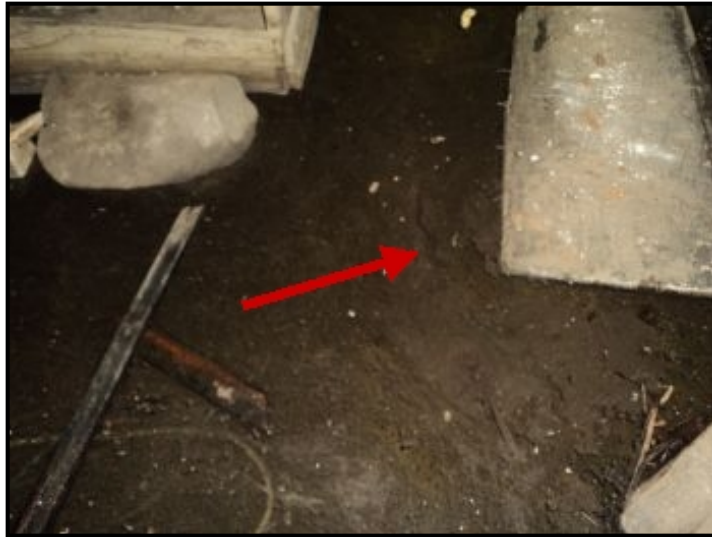
Page 18 Item: 13	Sump Pump	• Sump pump not operational at time of inspection due to no power. Recommend installing a professional grade sump pump system, including a battery back up. There is lots of water in this basement.

- Sump pump not operational at time of inspection due to no power. Recommend installing a professional grade sump pump system, including a battery back up. There is lots of water in this basement.

Because there was no power the sump pump could not function and the basement had 8 to 12 inches of water in it.

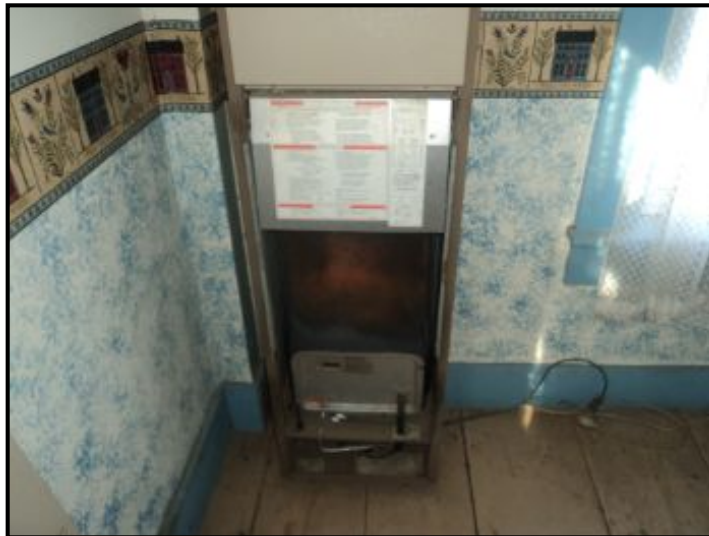
- Could not test due to no power.

The hot air furnace in the living room could not be tested. It is fueled by propane.

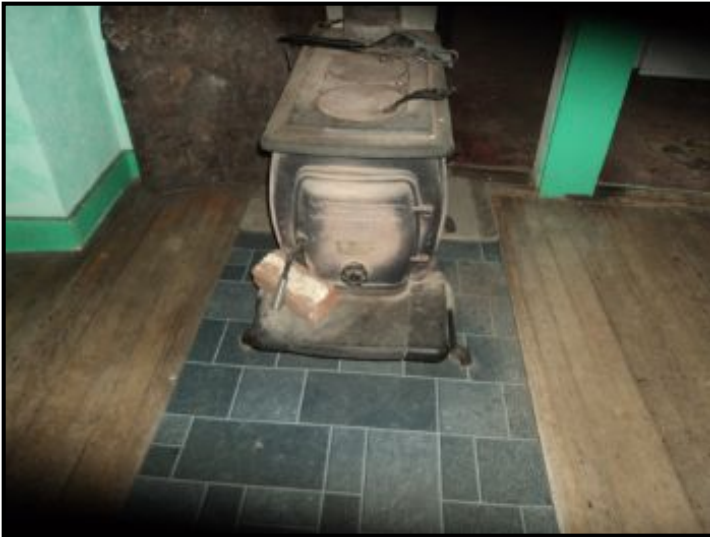
The wood stove appears to be functional.

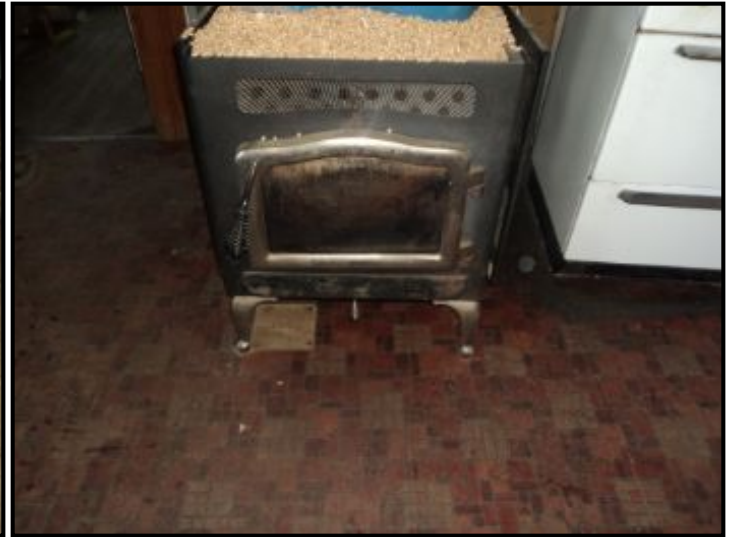
Page 20 Item: 9	Heater Conditions	• There is a Country Flame Pellet Stove noted in the kitchen. Model # LR-02. SN 2716. Manufacture date is unknown. This stove has an electrical problem and is not functional. Information comes from the listing agent.

• There is a Country Flame Pellet Stove noted in the kitchen. Model # LR-02. SN 2716. Manufacture date is unknown. This stove has an electrical problem and is not functional. Information comes from the listing agent.

The pellet stove does not function. This information comes from the sales agent. There is no hearth.

Page 21 Item: 10	Hearth Conditions	• A hearth pad will need to be added under the pellet stove to meet insurance requirements.

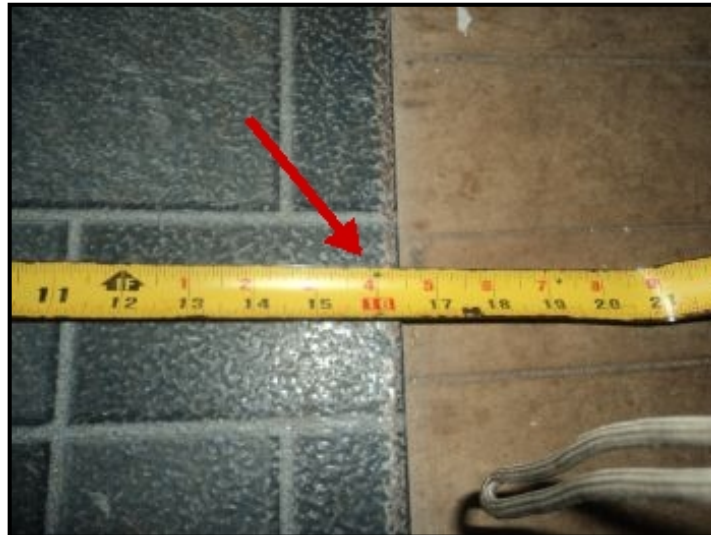
- The hearth for the wood stove in the dining room meets the current standard of 16 inches at the loading door.
- A hearth pad will need to be added under the pellet stove to meet insurance requirements.

The hearth for the wood stove meets the current standard of 16 inches at the loading door.

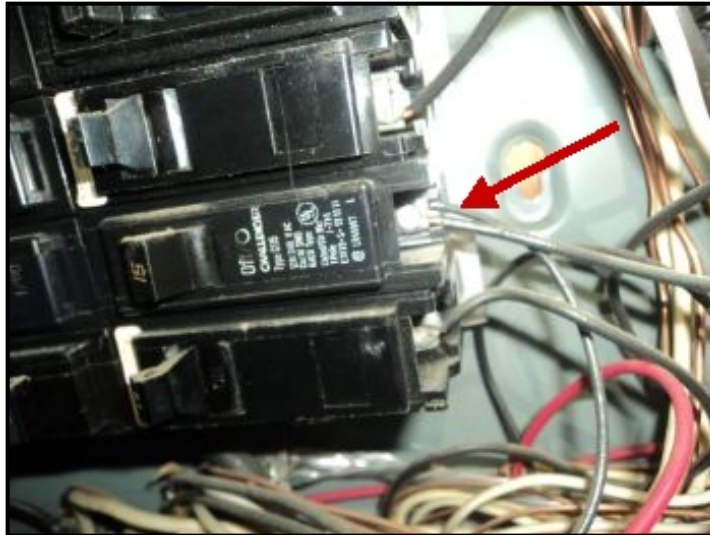
Page 22 Item: 4	Breakers	• Double tapped breaker(s) inside panel box (more than one electrical conductor attached) in the main panel. This is not standard practice, and may cause overheating or even an electrical fire. Recommend evaluation by an electrician. Double tapping and lugging can create hot spots on breakers and neutral bars because they are not tightened to the correct torque--especially if two different size conductors are used. Because the hot [black] and neutral [white] wires are both current carrying conductors, the chance is then greater for potential hot spots. If the double tap or lug becomes loose, it begins to arc. As it arcs it builds up carbon. Carbon is then resistance and with more carbon buildup the more difficult it is for the conductor to make contact, thus increasing the current. The end result can be the breaker tripping because of the loose connection [current exceeding the rating of the breaker], or signs of overheating such as discolored wires, melted wires, etc, or even fire. It is suggested that a licensed electrician be contacted for further evaluation and repair.

- All of the circuit breakers appeared serviceable.
- Double tapped breaker(s) inside panel box (more than one electrical conductor attached) in the main panel. This is not standard practice, and may cause overheating or even an electrical fire. Recommend evaluation by an electrician. Double tapping and lugging can create hot spots on breakers and neutral bars because they are not tightened to the correct torque--especially if two different size conductors are used. Because the hot [black] and neutral [white] wires are both current carrying conductors, the chance is then greater for potential hot spots. If the **double tap** or lug becomes loose, it begins to arc. As it arcs it builds up carbon. Carbon is then resistance and with more carbon buildup the more difficult it is for the conductor to make contact, thus increasing the current. The end result can be the breaker tripping because of the loose connection [current exceeding the rating of the breaker], or signs of overheating such as discolored wires, melted wires, etc, or even fire. It is suggested that a licensed electrician be contacted for further evaluation and repair.

There was one double tap breaker noted in the electrical panel.

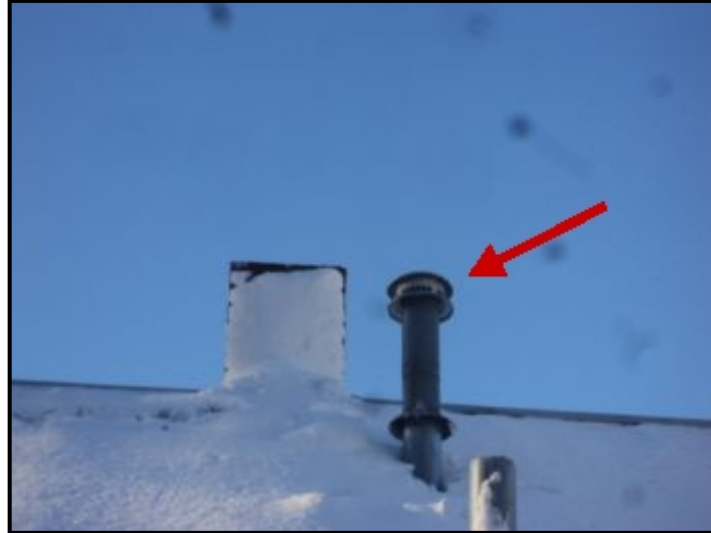
The spark arrestor/rain cap on the vent pipe for the hot water heater is in serviceable condition.

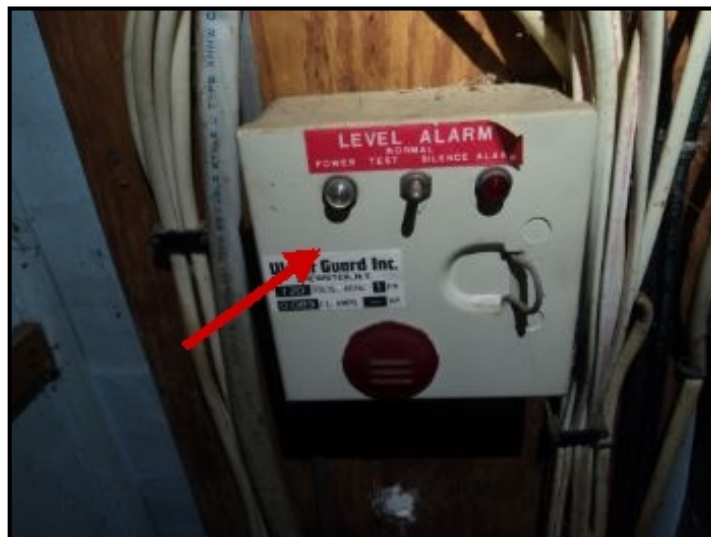
- There was an alarm system noted for the waste pump system noted. It was not tested.

The ejection pump alarm could not be tested because there was no power.

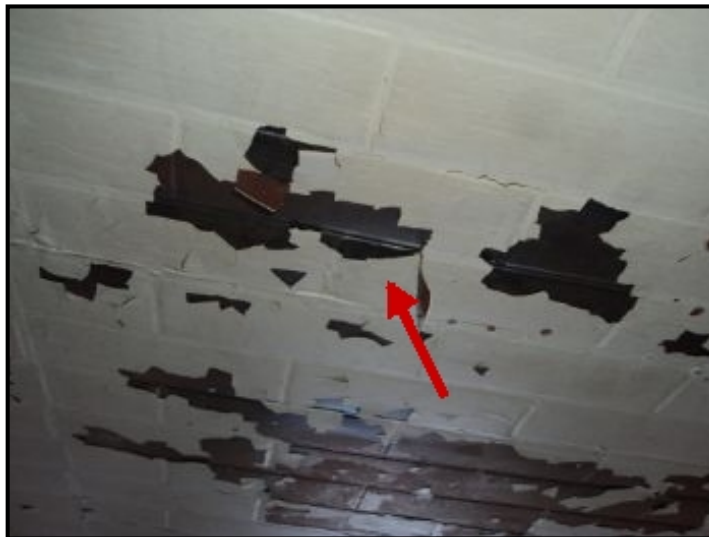
3. Ceiling Condition

Page 27 Item: 3	Ceiling Condition	• Peeling paint noted. Repair needed.
---	-----------------	-------------------	---------------------------------------

- Peeling paint noted. Repair needed.

The ceiling in the kitchen is peeling. This paint could contain lead.

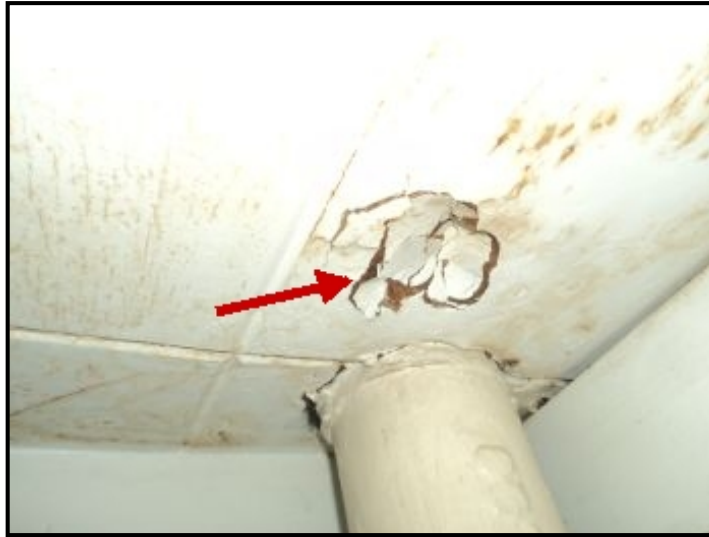
Page 31 Item: 3	Ceiling Condition	<ul style="list-style-type: none"> • Evidence leaking was noted around the plumbing vent pipe. Repair is needed.

- Evidence leaking was noted around the plumbing vent pipe. Repair is needed.

The ceiling was wet around the plumbing vent pipe in the bathroom.

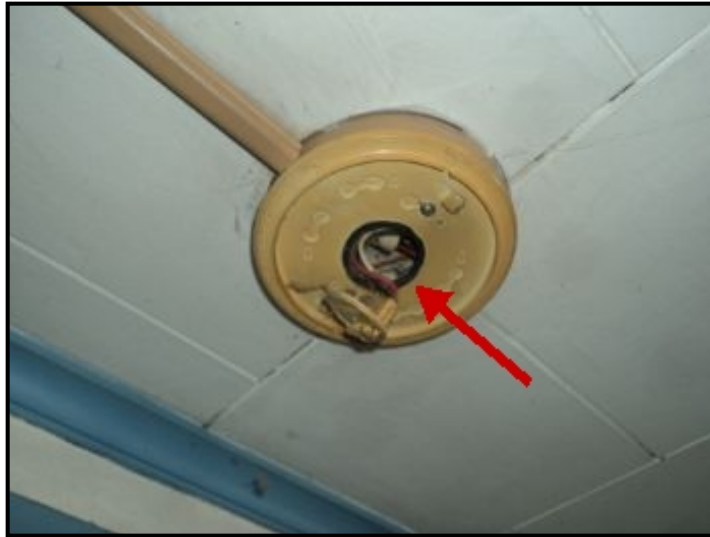
- ****Smoke Detectors****
- Smoke detector was disconnected. Install a smoke/carbon monoxide detector as soon as possible.

The smoke detector was disconnected in the living room. There were no other detectors noted in the house.

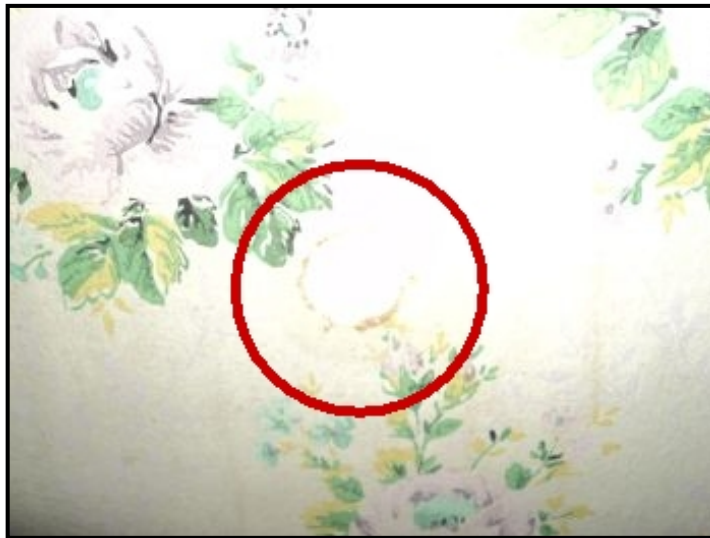
- Note: It appears that this room only was insulated from the inside with blown in insulation.

The outside wall in the front bedroom appears to be the only room that has blown in insulation.

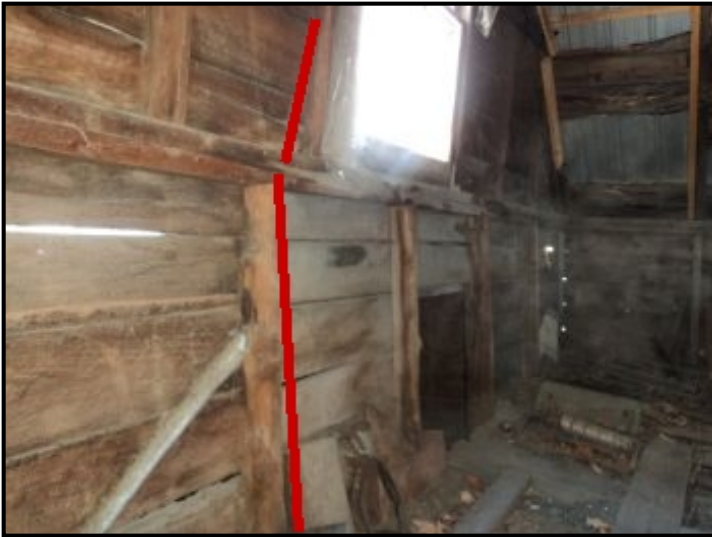
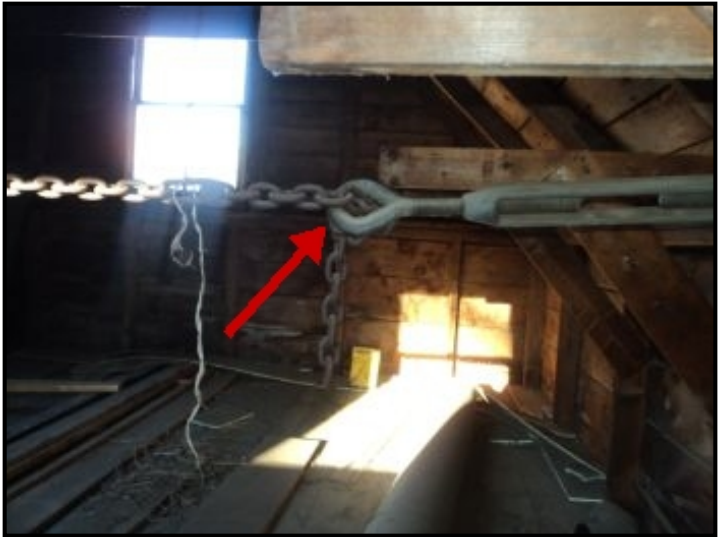
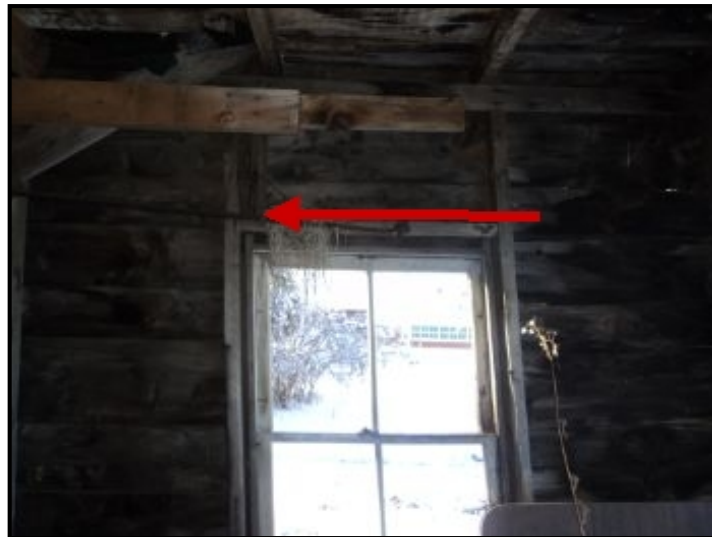
Page 46 Item: 1	Foundation Conditions	<ul style="list-style-type: none"> • There appears to be concrete footing on three sides of the garage. There is no telling how deep the footing is, but the structure is racked toward the back and the back wall is buckled. See pictures in wall section.

Page 46 Item: 7	Walls	<ul style="list-style-type: none"> • Side walls are racked and back wall is buckled. This garage needs attention. Turnbuckle is noted on the side walls. Contact a license builder for further evaluation and repair.

- 2x4 open studs noted.
- Side walls are racked and back wall is buckled. This garage needs attention. Turnbuckle is noted on the side walls. Contact a license builder for further evaluation and repair.

The back wall of the garage is buckled and the garage is racked.

The walls of the garage are held together by a chain and turnbuckle.

It is difficult to see in the picture but the garage is racked, leaning toward the back.

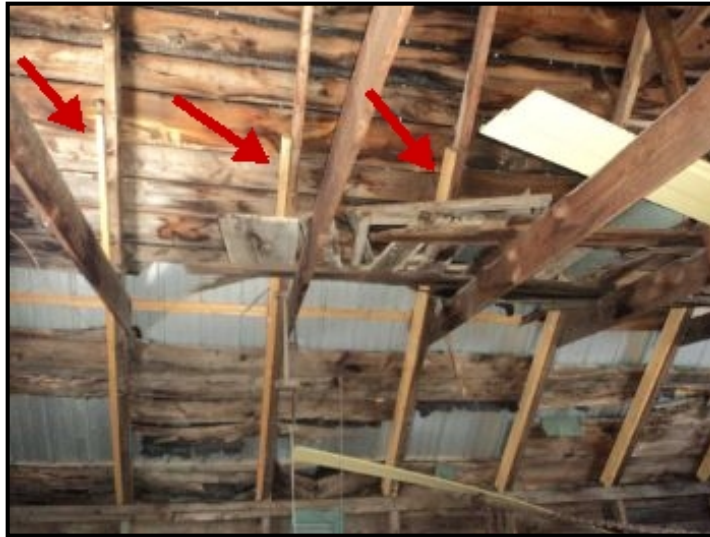
8. Rafters & Ceiling

Page 47 Item: 8	Rafters & Ceiling	<ul style="list-style-type: none"> • 2x4 rafters noted. These rafters are sistered, but the sistered rafters do not go all the way to the ridge for full support.

- 2x4 rafters noted. These rafters are sistered, but the sistered rafters do not go all the way to the ridge for full support.

The rafters in the garage are only partly sistered. Not sure why they did not go all the way to the ridge.

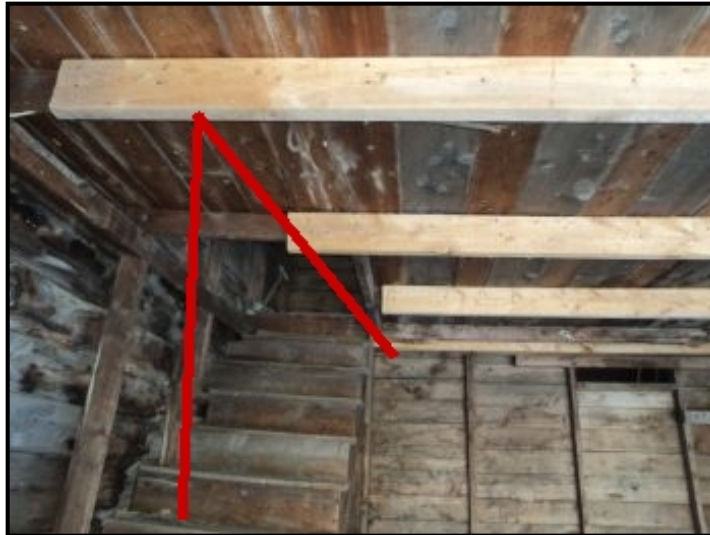
Page 48 Item: 13	Loft Condition	<ul style="list-style-type: none"> • The loft should not be used until the proper supports are installed. See picture.

- The loft should not be used until the proper supports are installed. See picture.

The loft is supported by sistered floor joists, but no support posts. There should be a post and header added at the loft stairs.
